Manhole Inspection Summary

Manhole # S17K__006MH

Insp Date: **4/10/08 11:00 AM**

Location Address: **135 warwick st**

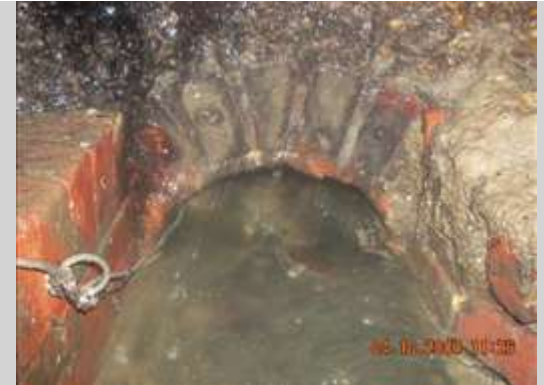
12 O'Clock Outflow

12 in. Circular Gravity Sewer
Pipe Out @ 12 O'Clock

Pipe Height: **14.4** (in.) Rod and Bar (Angled)
Pipe Material: **Clay** ☐ Pipe Lined
Invert Depth: **23.79** (ft.) Flow Characteristics: **Fast**
Deposits: ☒ None ☐ Mud ☐ Gravy ☐ Debris ☐ Grease
Silt Depth: **0** (in.) Deposits Extent:
Infiltration: **None** Pipe Seal Cond: **Sound**

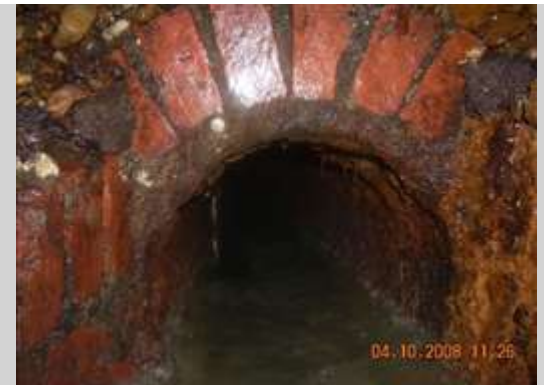
3 O'Clock Inflow

12 in. Circular Gravity Sewer
Pipe In @ 3 O'Clock

Pipe Height: **14.4** (in.) Rod and Bar (Angled)
Pipe Material: **Clay** ☐ Pipe Lined
Invert Depth: **23.44** (ft.) Flow Characteristics: **Fast**
Deposits: ☒ None ☐ Mud ☐ Gravy ☐ Debris ☐ Grease
Silt Depth: **0** (in.) Deposits Extent:
Infiltration: **None** Pipe Seal Cond: **Sound**

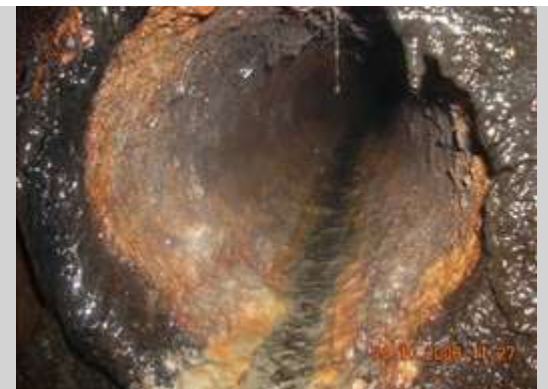
11 O'Clock Inflow

8 in. Circular Gravity Sewer

Pipe In @ 11 O'Clock

Pipe Height: **8.4** (in.) Rod and Bar (Angled)
